**OLIVERIAN DAM  
DAM-BREACH FLOOD ANALYSIS  
TOWNS OF BENTON AND HAVERHILL,  
NEW HAMPSHIRE**

**OLIVERIAN DAM**  
**DAM-BREACH**  
**FLOOD ANALYSIS**

DuBois & King, Inc.

Department of the Army  
New England District, Corps of Engineers  
Concord, Massachusetts

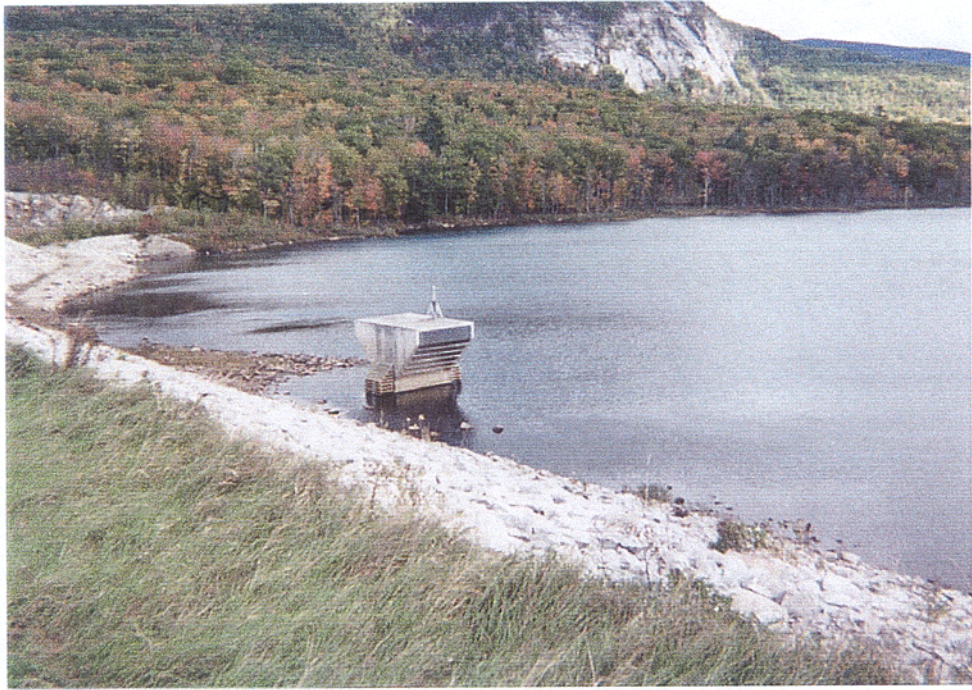
Oliverian Dam – Looking Upstream at Principal Spillway

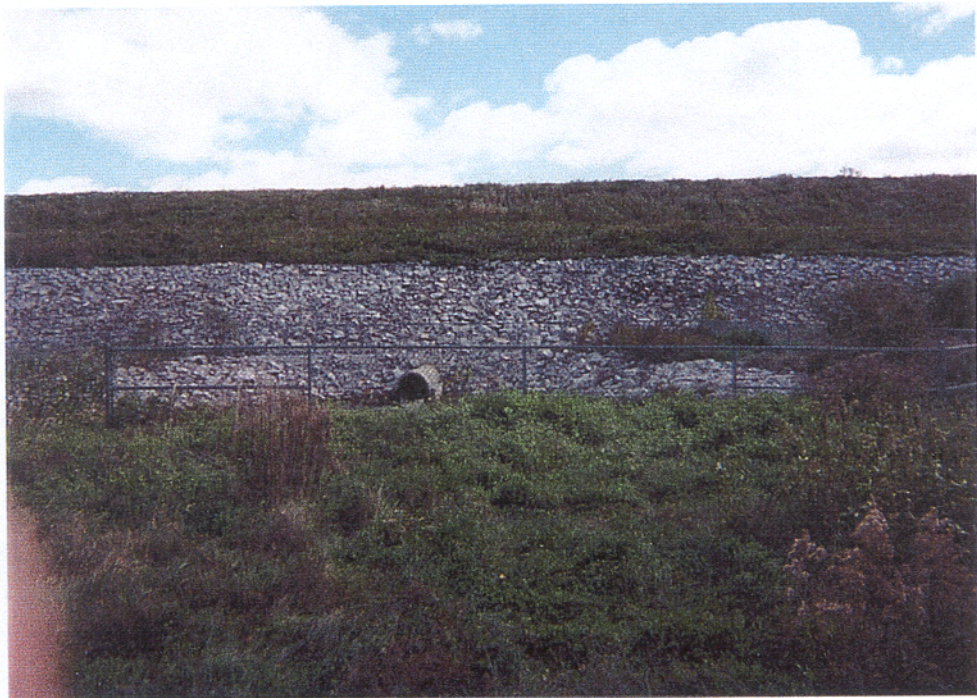
Oliverian Dam – Looking at Principal Spillway Discharge Outlet Pipe

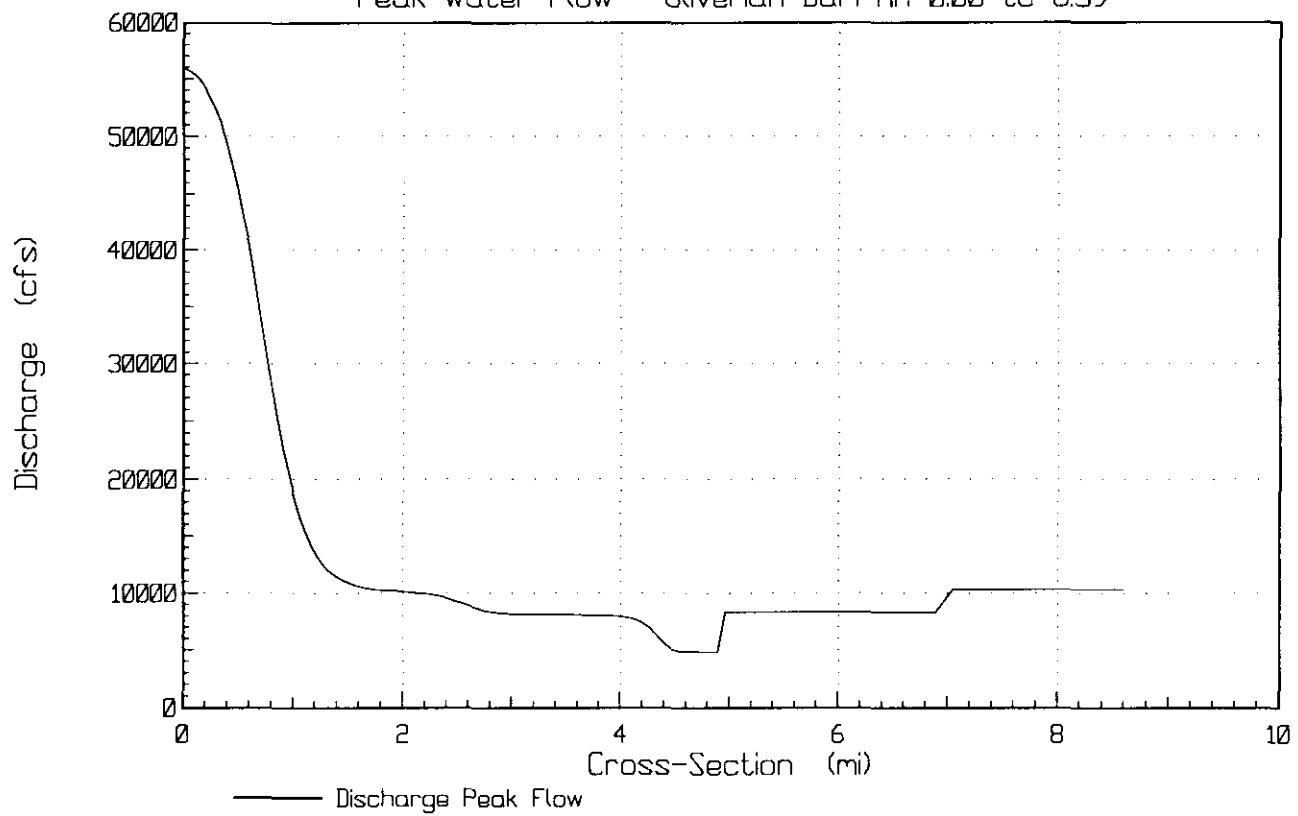
# Flood Discharge Summary - Storm-day Failure

Peak Water Flow - Oliverian Dam MM 0.00 to 8.59

Plates 3 - 6 show the pre-breach and dam-breach flood profiles for the Sunny-day dam failures. Plates 7-10 show the pre-breach and dam-breach flood profiles for the Storm-day dam failures. Plates 11 and 13 shows the breach discharge and stage hydrographs for selected cross sections throughout the reach. Plates 12 and 14 shows how the breach flood peak discharge varies with distance downstream.

Table 4 indicates the results of the dam failure analysis at various locations along the Oliverian Brook. The peak breach discharge attenuates from 56,000 cfs at Oliverian Dam, MM 0.00 to 4,900 cfs at MM 4.54. This reduction of approximately 90 % in the dam breach flood wave, is due to the valley characteristics of Oliverian Brook. The upper reach of Oliverian Brook, from the dam at MM 0.00 to MM 5.21, has a wide flood plain and a gradual valley slope of 21 feet per mile. This type of valley characteristic is conducive to flood wave attenuation. The lower reach of the Oliverian Brook, from MM 5.21 to MM 8.59, is a narrow valley with a steep valley slope of 97 ft per mile. Minimal attenuation and high velocities characterize a narrow, steep river valley.
